Manhole Inspection Summary

Manhole # S27S1_003MH

Location Address: **810 W. Potapsco Ave.**

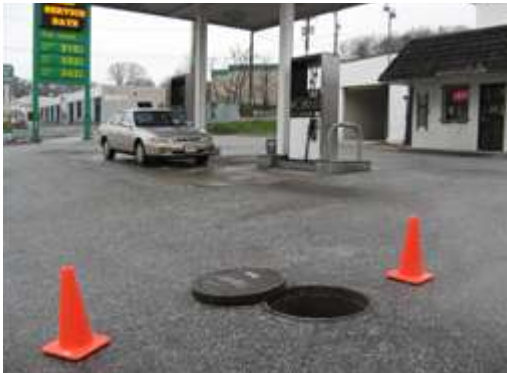
Location View

Comments **Within Gas Station premises**

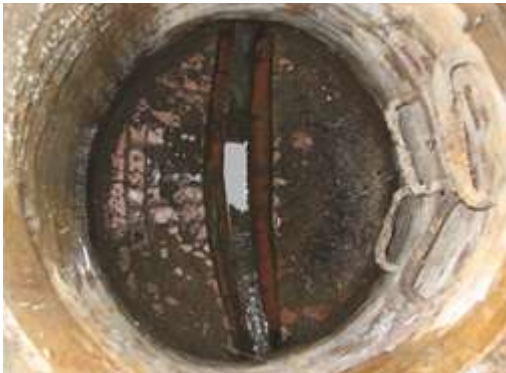
Top View

Cover Shape: **Circular** Diameter: **24** (in.) Length: (in.) Dist A/B Grade: **0** (in.)

Type: **Sanitary** Condition: **Sound** Cover Material: **Cast Iron**

Frame Offset: **1** (in.) Condition: ☒ Sound ☐ Cracked ☐ Leaks

Steps Count: **4** Missing: **0** ☒ **Corroded**
